# 1989 - CID510160\_Tazewell County\_CFPF-5

**Funding Opportunity:** 1448-Virginia Community Flood Preparedness Fund - Study Grants - CY23 Round 4  
**Funding Opportunity Due Date:** Nov 12, 2023 11:59 PM  
**Program Area:** Virginia Community Flood Preparedness Fund  
**Status:** Under Review  
**Stage:** Final Application

## Hazard Mitigation Plan Update

## Introduction

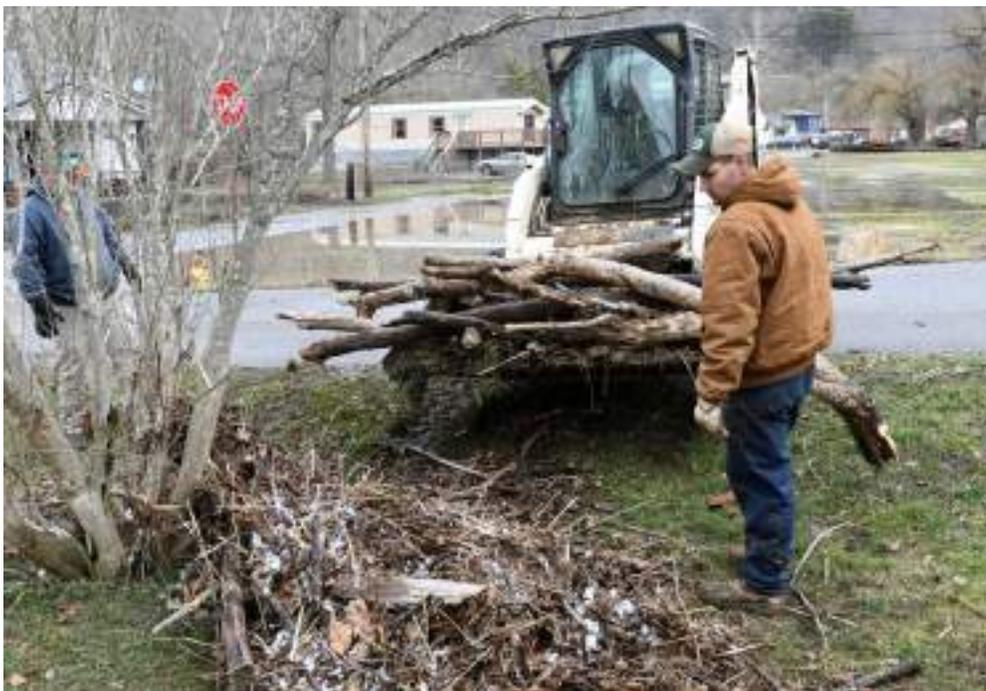
Natural debris, such as woody vegetation and sediment from erosion, can also restrict the natural capacity of the stream (e.g., sediment building up on the streambed) and contribute to flooding. Natural debris left by a flooding in Richlands flowing a 2020 event is shown in Figure 614. When not cleared, especially after a flood event where areas pile up with debris, a hazard is created as the stream is essentially dammed and increases the likelihood that a rainfall event will become a major flood event.

*Figure 614: Flood Debris from February 2020 flooding in Richlands, VA<sup>23</sup>*

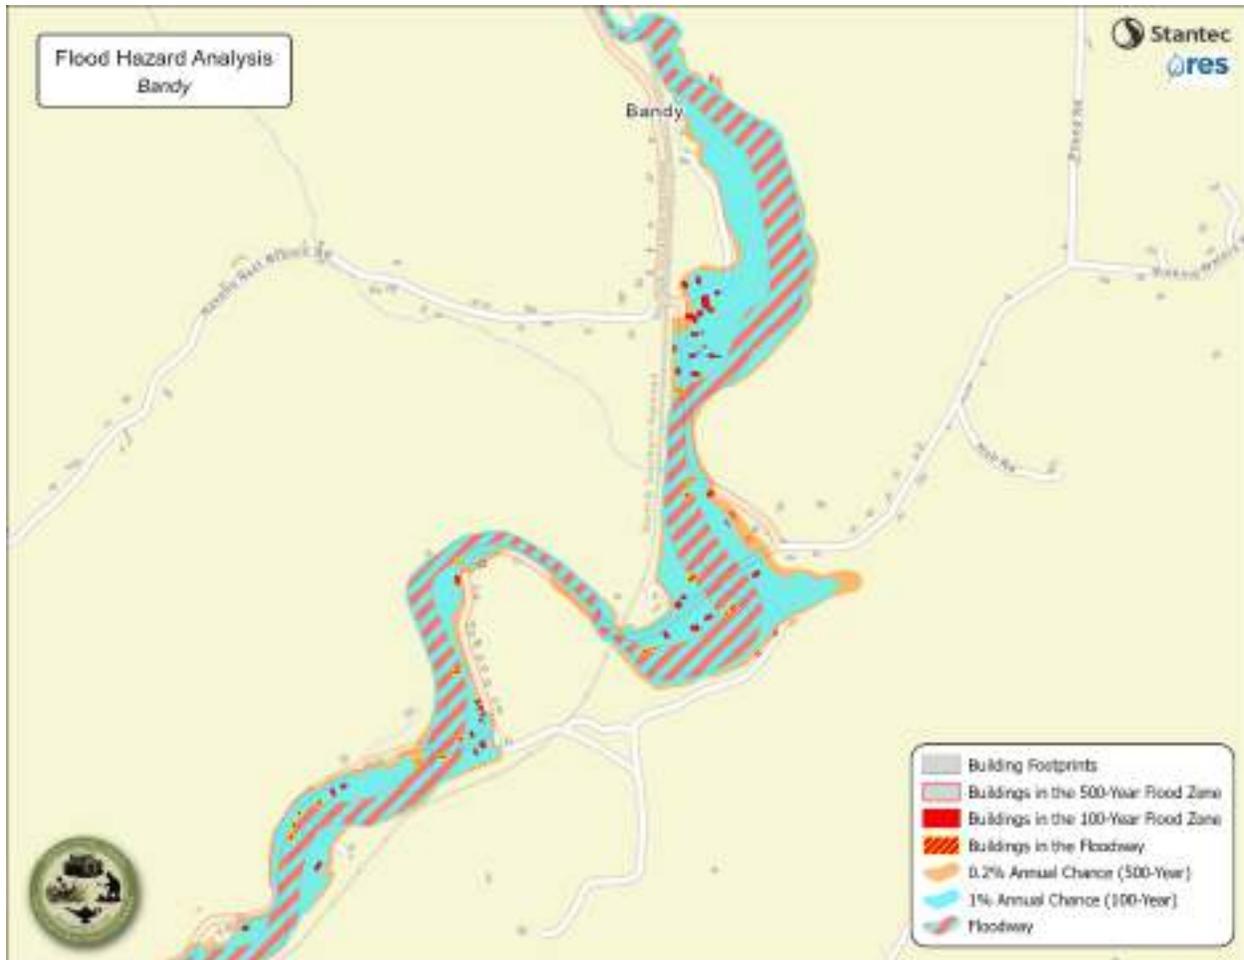
Figure 630: Flood Hazard Analysis – Bandy Area

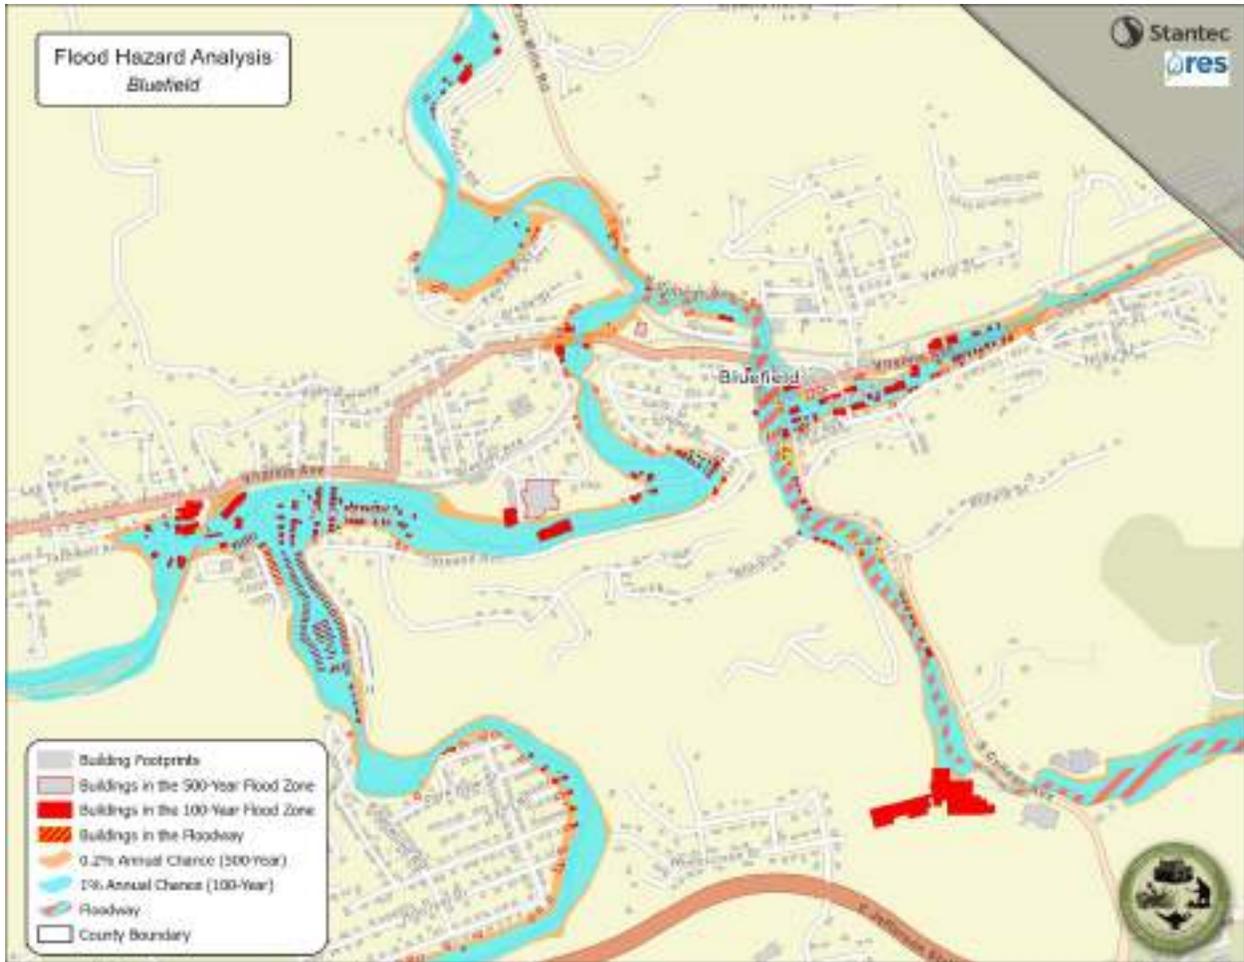
Figure 632: Flood Hazard Analysis – Bluefield Area

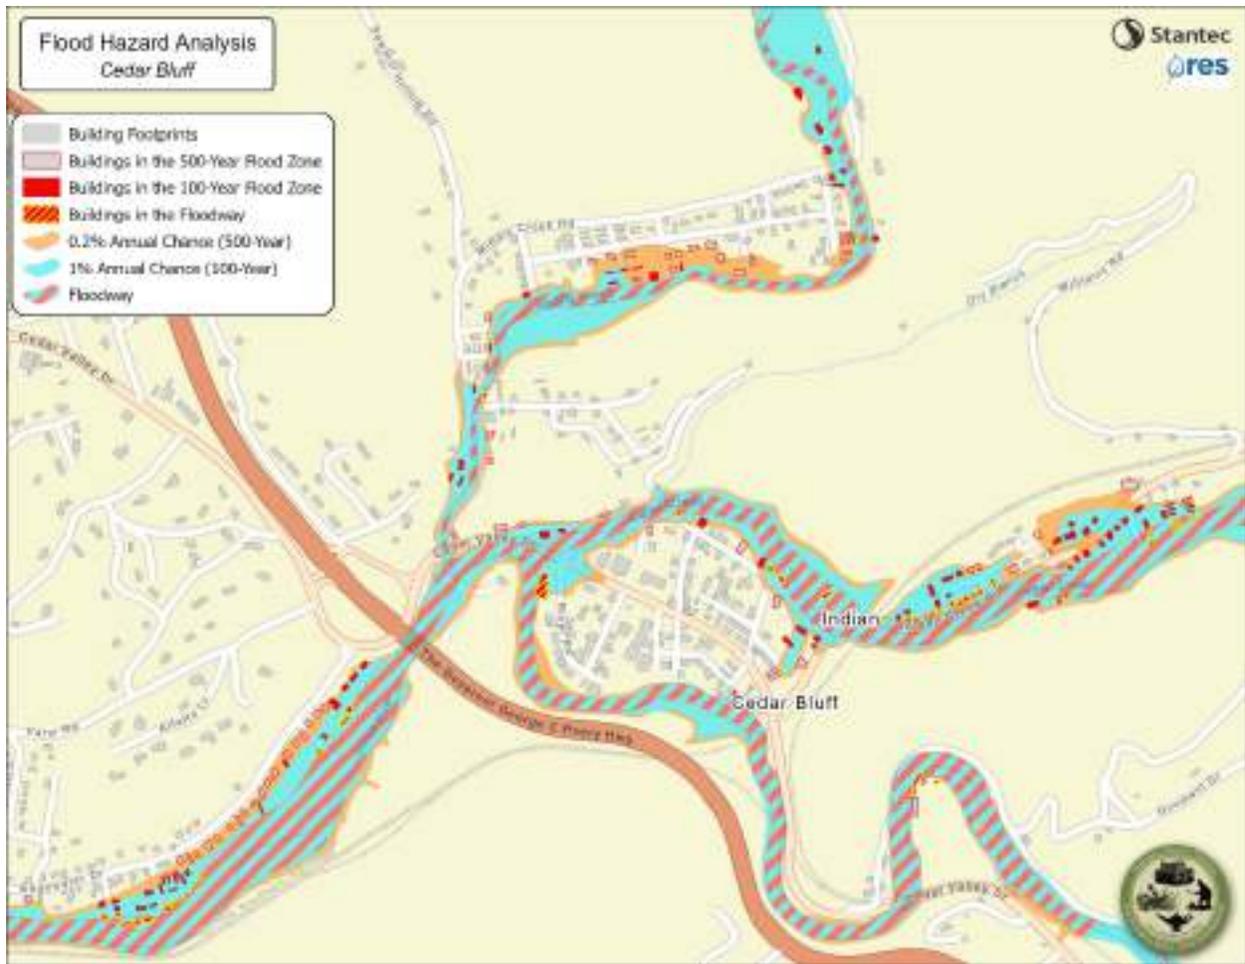
Figure 633: Flood Hazard Analysis – Cedar Bluff Area

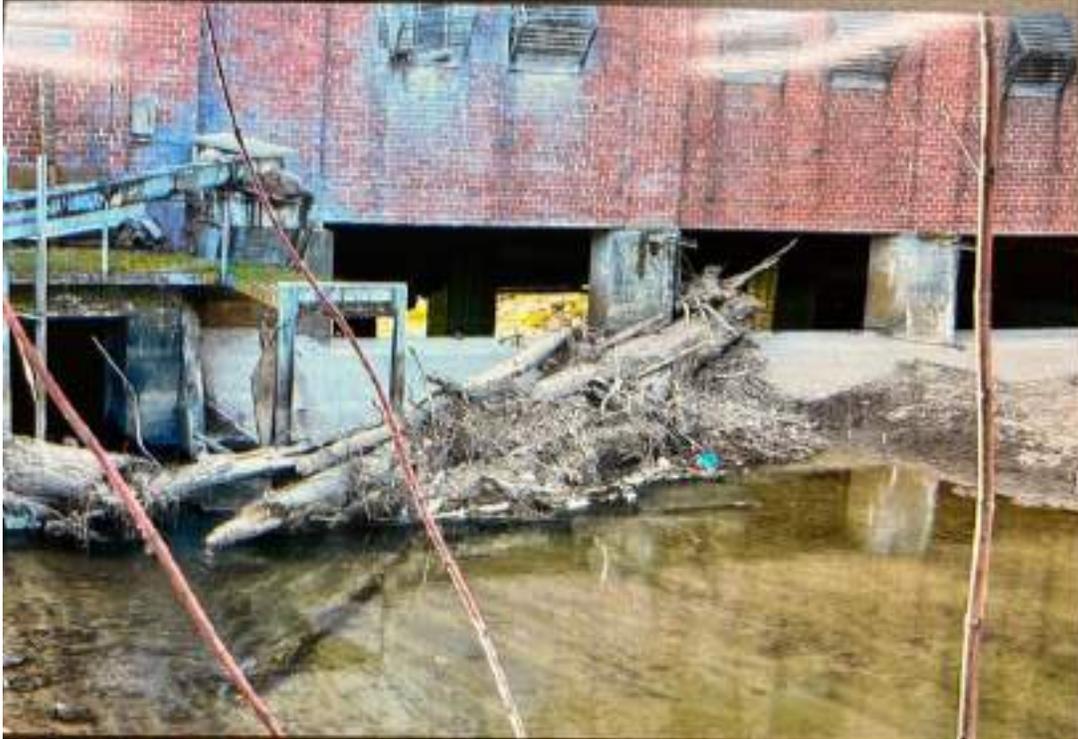
*Figure 642: Debris Gathered on Upstream Side of Abandoned Mill Building in North Tazewell*

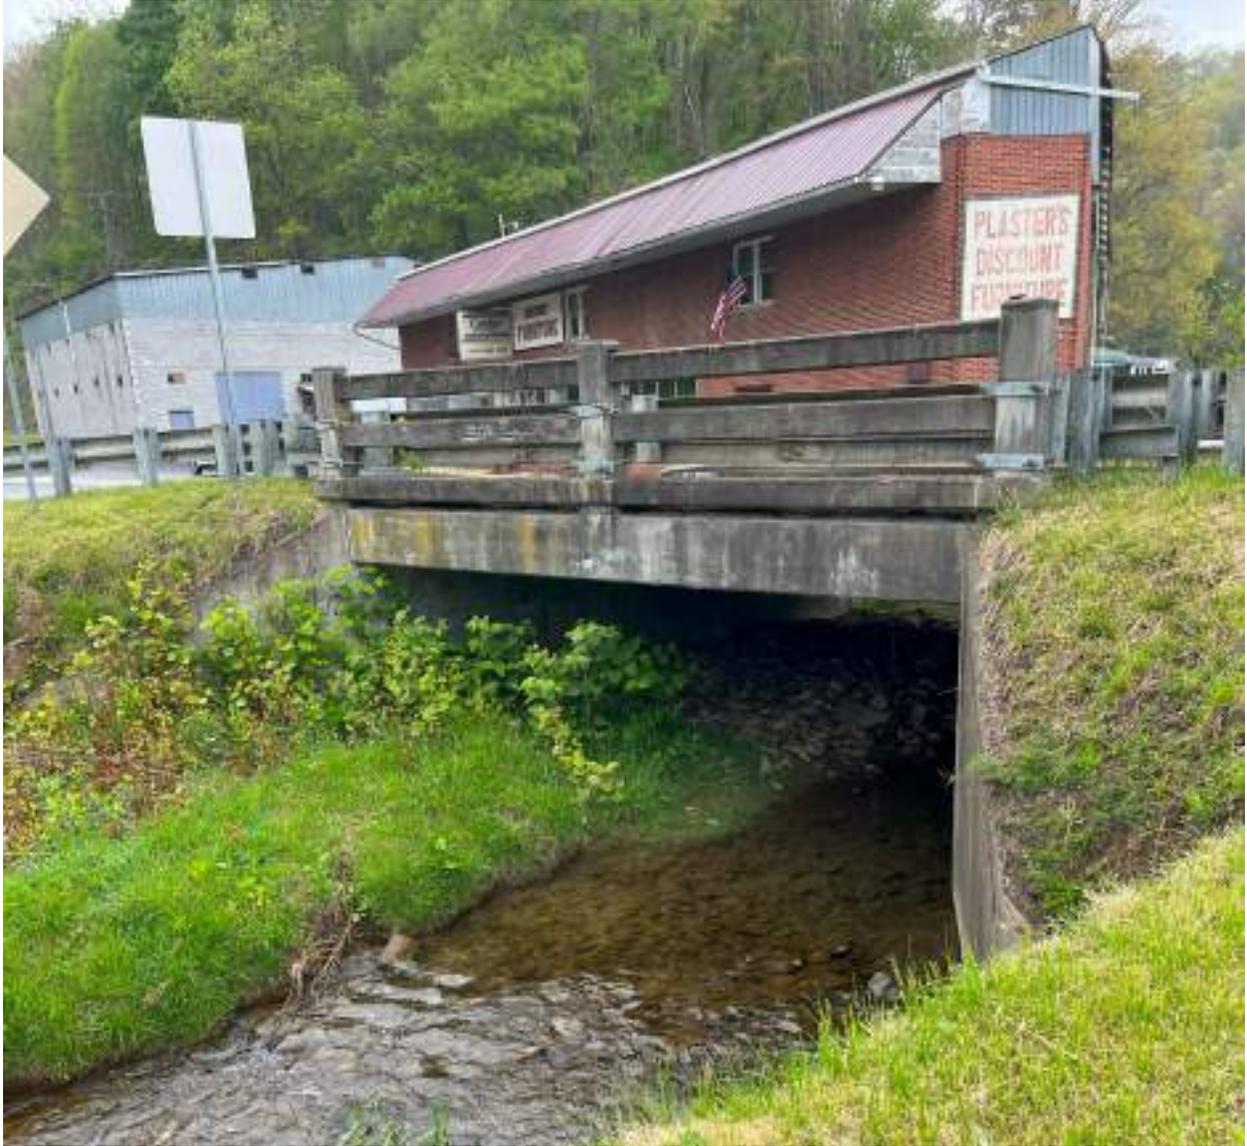
Figure 727: Culvert crossing Mill Creek

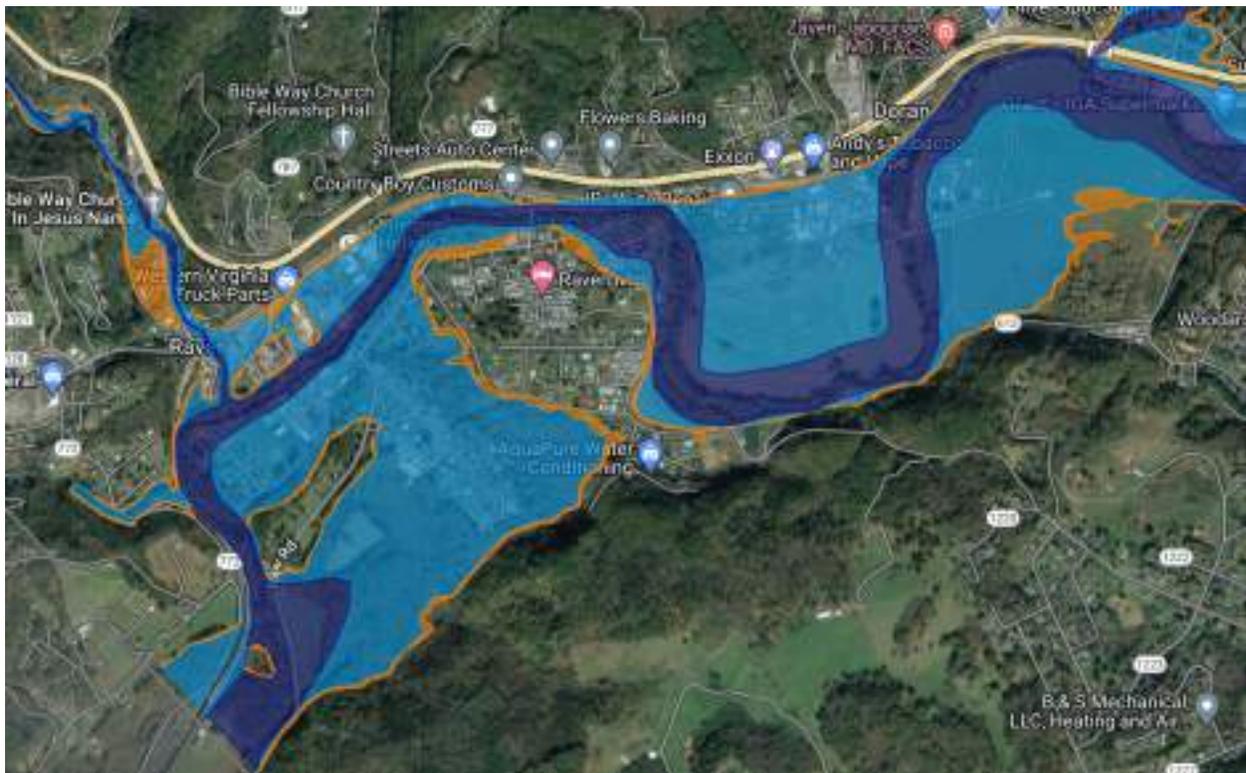
Figure 729: Traditional 1D Modeling
