VDEM - Lancaster County- Westland Beach - Windmill Point Shoreline

BENEFIT COST ANALYSIS REPORT

BRIC 2022

Shoreline Evolution Lancaster County, Virginia Chesapeake Bay and Rappahannock River Shorelines

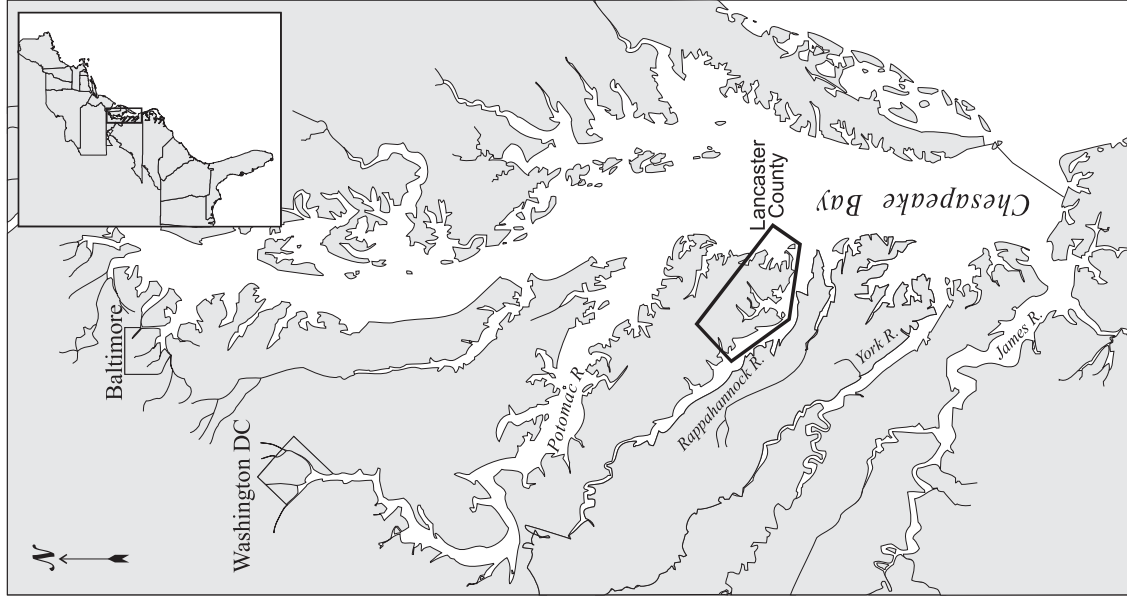
Figure 1. Location of Lancaster County within the Chesapeake Bay estuarine system.

The purpose of this report is to document how the dunes along the Bay and river shores of Lancaster (Figure 1) have evolved since 1937. Aerial imagery was taken for most of the Bay region beginning that year, and it is this imagery that allows one to assess the geomorphic nature of shore change. Aerial imagery shows how the coast has changed, how beaches, dunes, bars, and spits have grown or decayed, how barriers have breached, how inlets have changed course, and how one shore type has displaced another or has not changed at all. Shore change is a natural process but, quite often, the impacts of man through shore hardening or inlet stabilization come to dominate a given shore reach. Most of the change in shore positions will be quantified in this report. Others, particularly very irregular coasts, around inlets, and other complicated areas will be subject to interpretation.

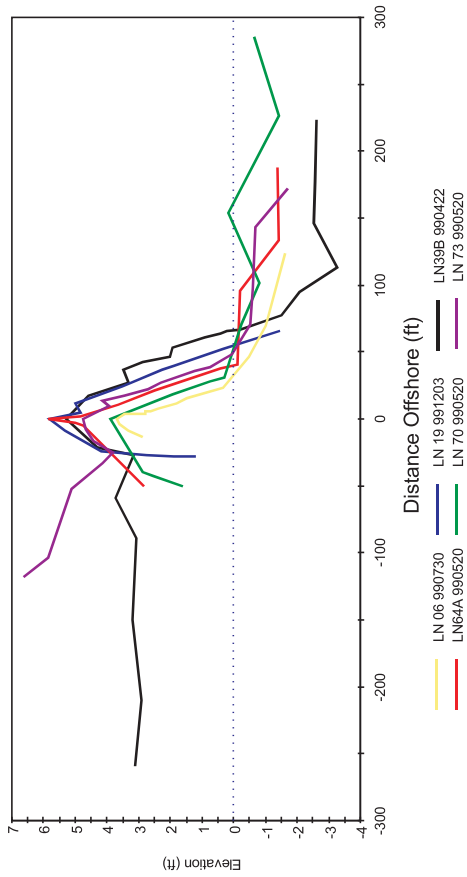
Figure 5. Variability of dune and beach profiles in Lancaster County.

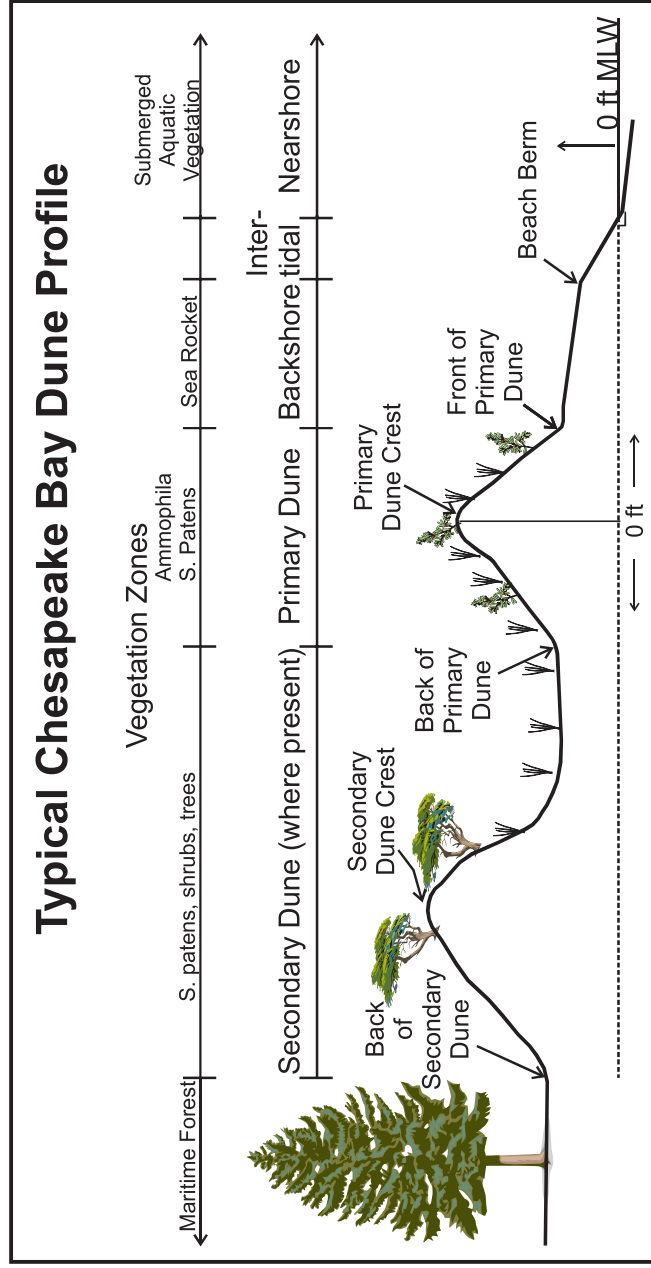
Figure 6. Typical profile of a Chesapeake Bay dune system (from Hardaway *et al.*, 2001).

Once the aerial photos were orthorectified and mosaicked, the shorelines were digitized in ArcMap with the mosaics in the background to help delineate and locate the shoreline. For Lancaster' coast, an approximation to mean low water (MLW) was digitized. This often was defined as the "wetted perimeter" on the beach sand as the last high water location. In areas where the shoreline was not clearly delineated on the aerial photography, the location was estimated based on the experience of the digitizer. Digitizing the shoreline brings in, perhaps, the greatest amount of potential error because of the problems of image clarity and definition of shore features. A series of Lancaster dune site profiles are displayed in Figure 5 which shows beach/dune variability. Figure 6 shows the relationship of MHW, MLW and beach/dune system components.

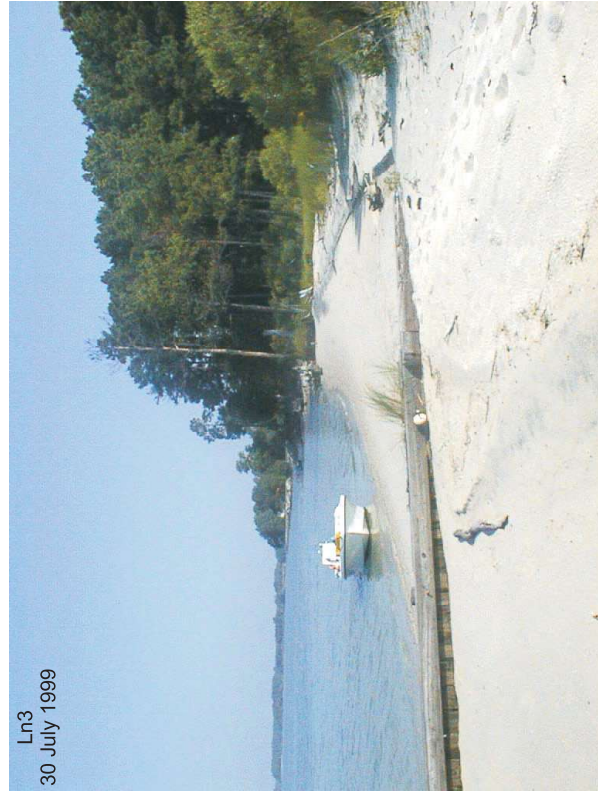
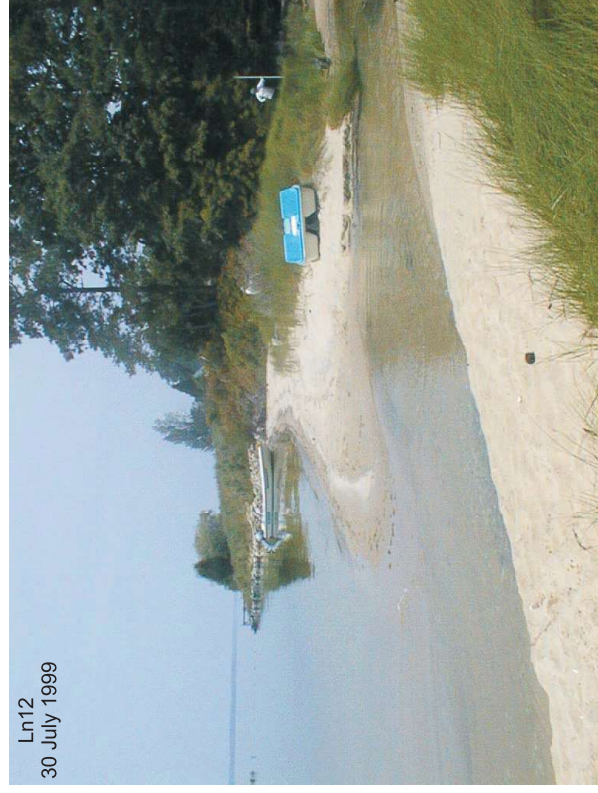
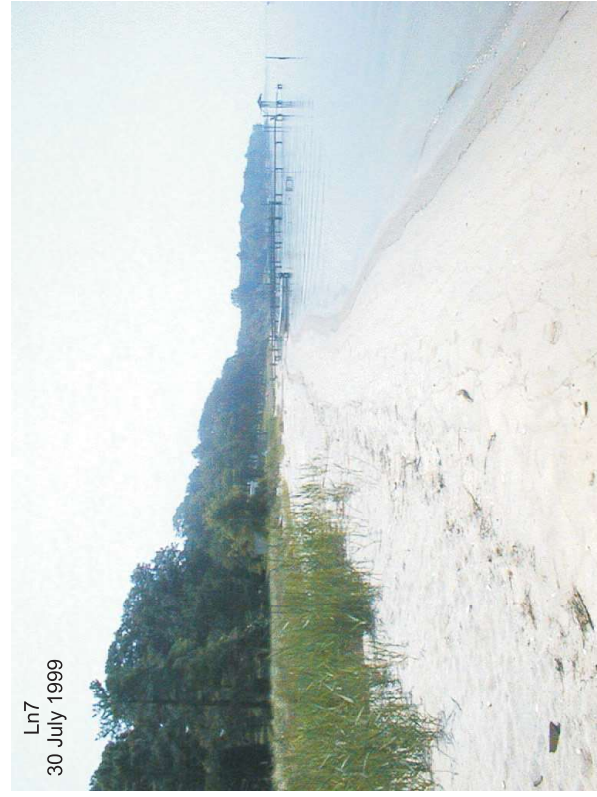
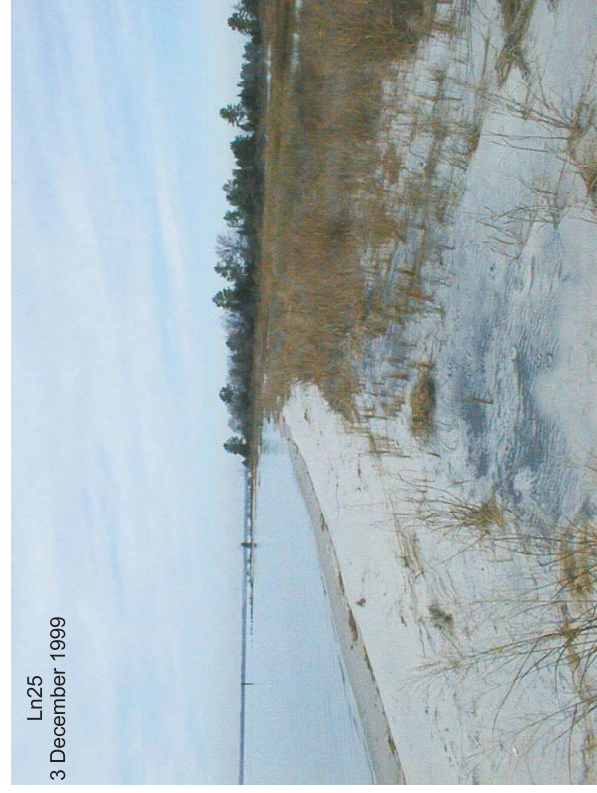
Figure 7. Selected dune site ground photos in Reach I.

Dune site LN3 has been stable for the last 30 years or so and should remain so for the near term (Figure 7). Site LN4 that occurs across a creek mouth has advanced and receded over time and will most likely continue that trend so it might be deemed erosional in that regard. Site LN5 appears stable as long as the bounding marsh headlands remain intact.

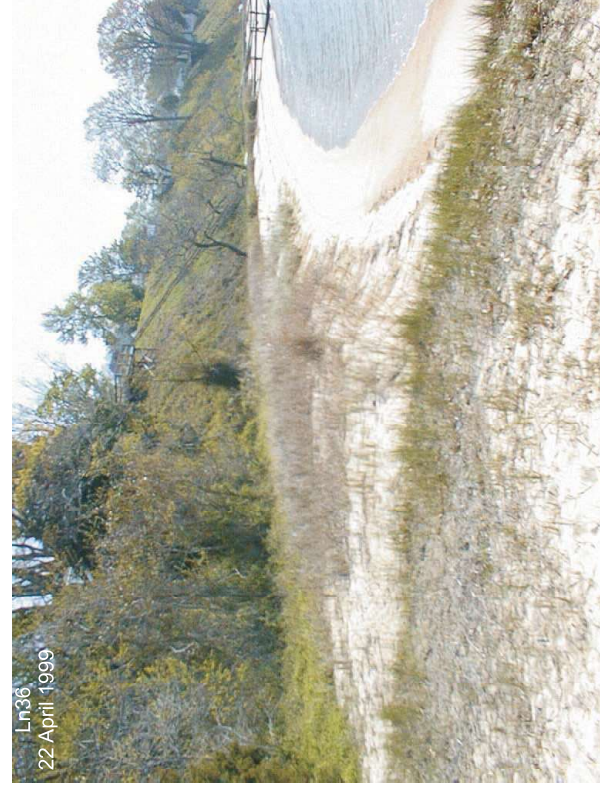
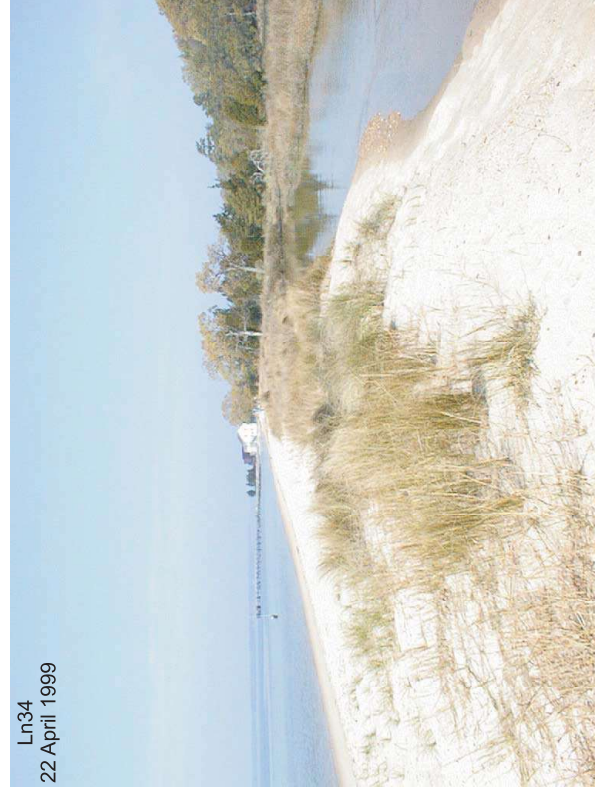
Figure 8. Selected dune site ground photos in Reach III.

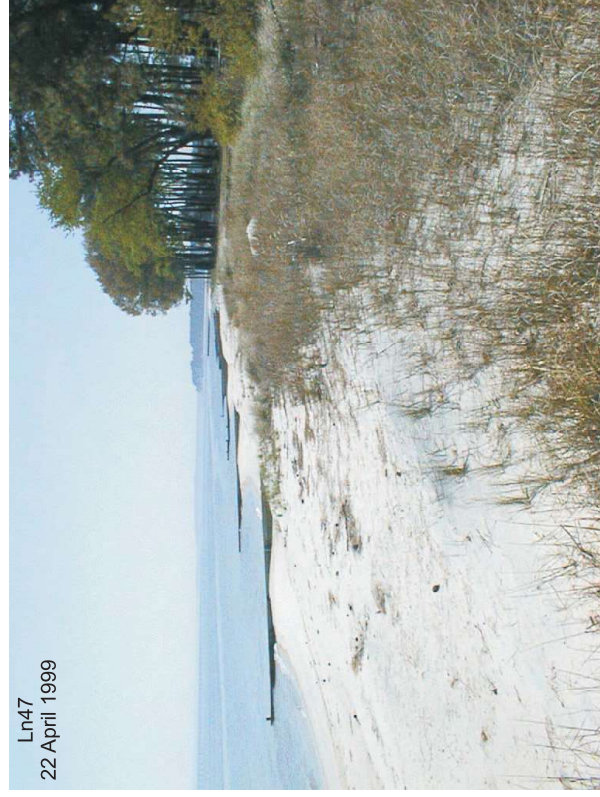
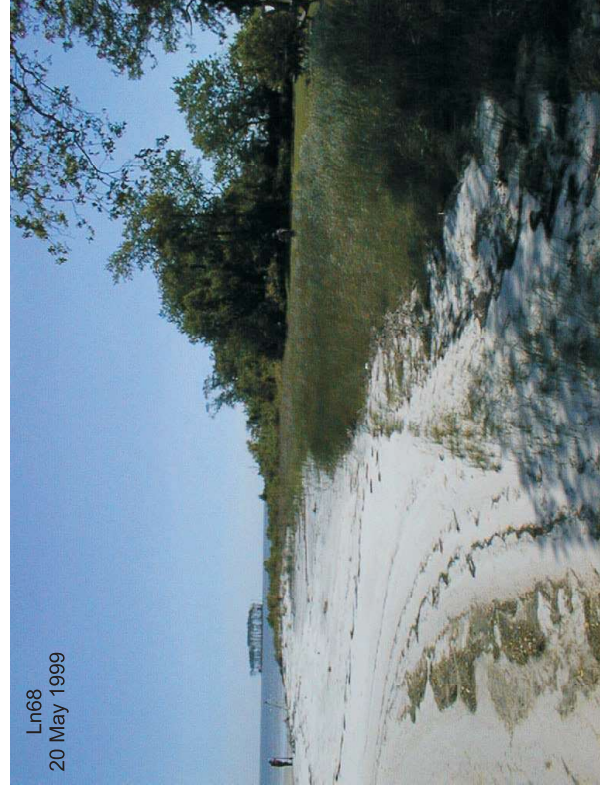
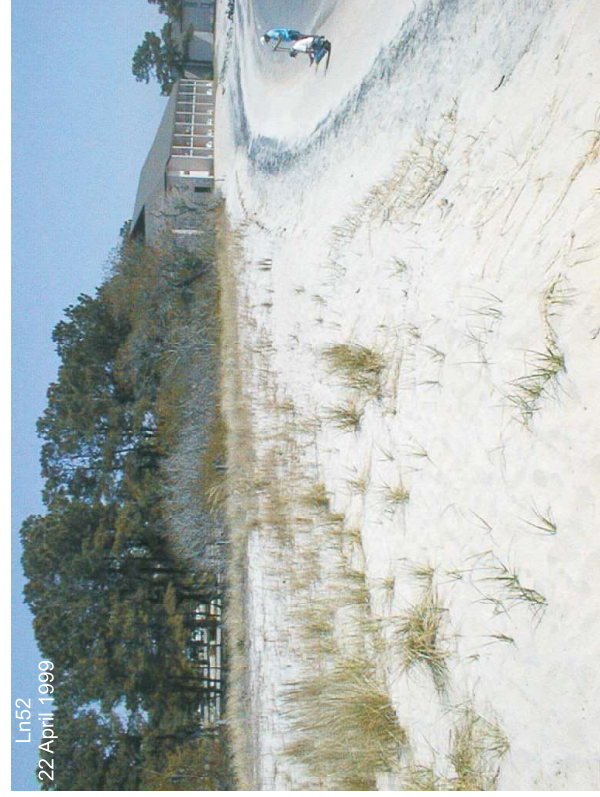
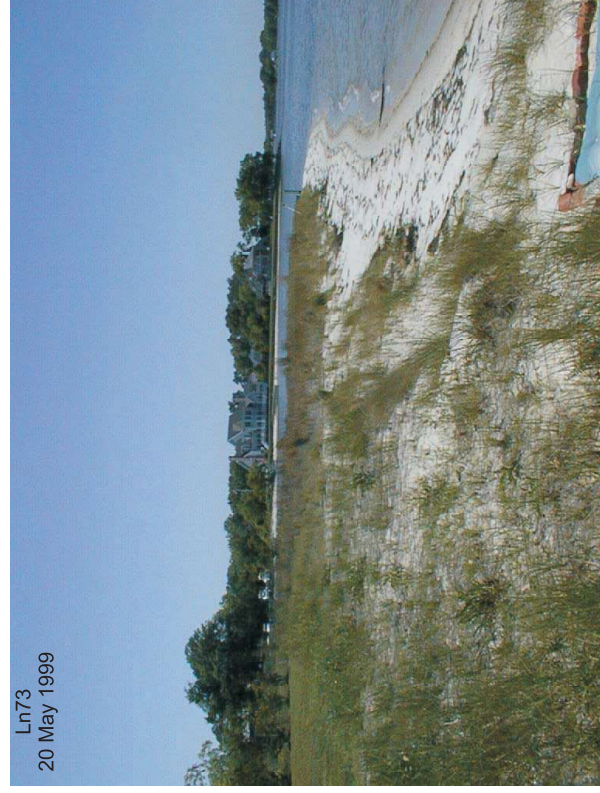
Figure 9. Selected dune site ground photos in Reach IV and V.

Along the end of Poplar Neck, LN64A and LN65 appear to be in an erosional/transgressive state while LN66 is stable if not advancing. Site LN67 is presently in a stable configuration but will recede as the adjacent headland erodes, and LN68 appears stable to accretionary for the near term (Figure 9).

Site LN69 is stable between groins, and LN70 is still mobile between a revetment and breakwater but might become stable over time as it evolves between these man-made headlands. A groinfield helps maintain the stability of LN71 and LN72 in a stable embayment. Site LN73 also appears stable between a jetty and groin (Figure 9).
