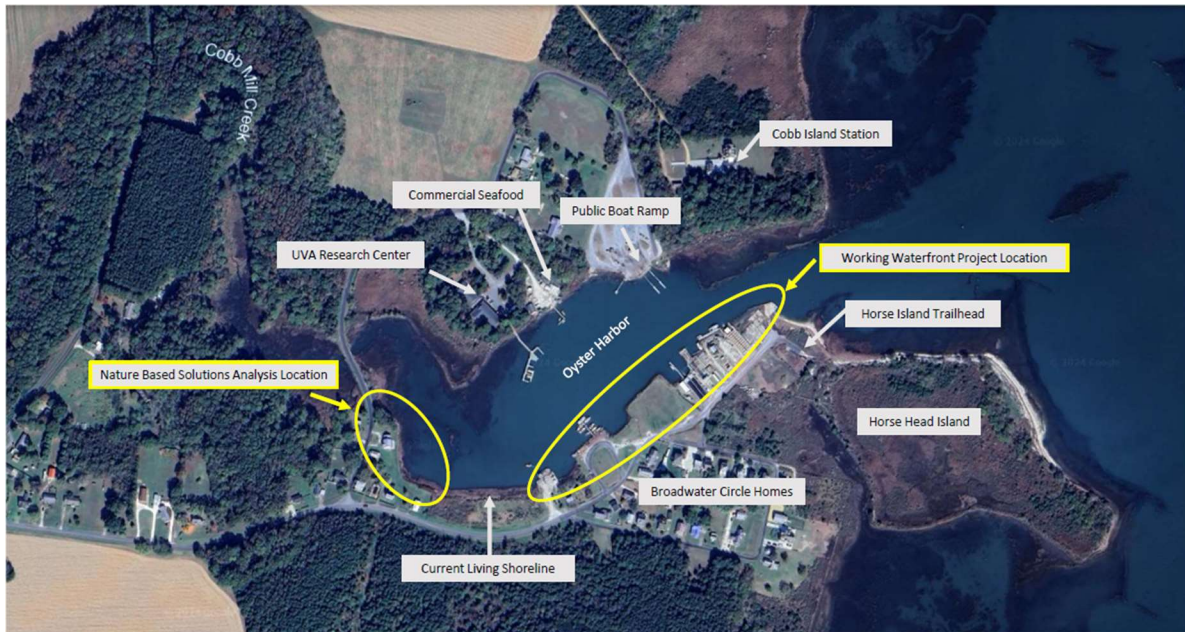
Figure 1: Aerial view from Google Earth of the Oyster Harbor area with referenced assets labeled. The yellow outlines indicate the locations of the proposed project.

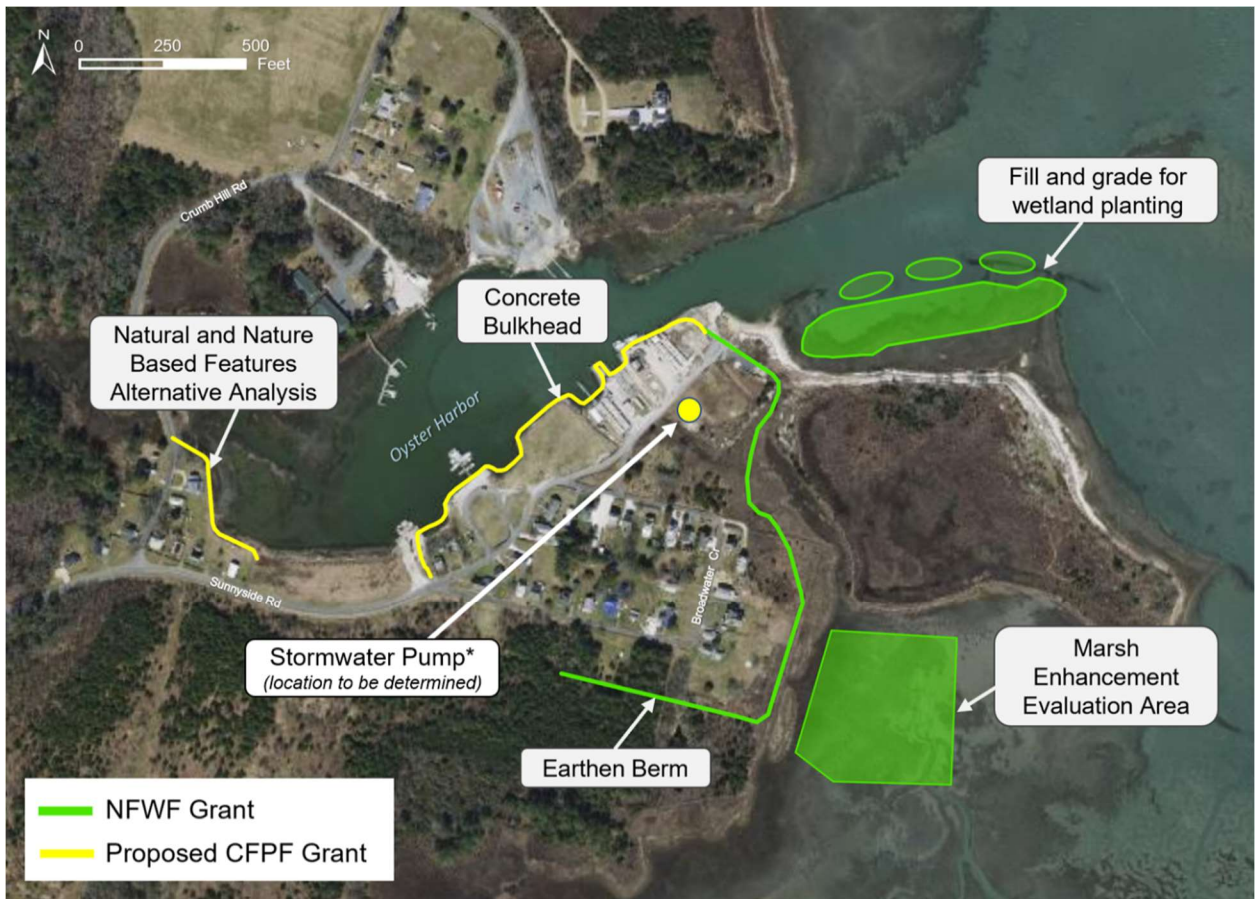
Figure 3: The combination of the NFWF (green) and proposed CFPF (yellow) design elements provide flood protection for Oyster Village. \*Location of stormwater pump to be determined during preliminary design.

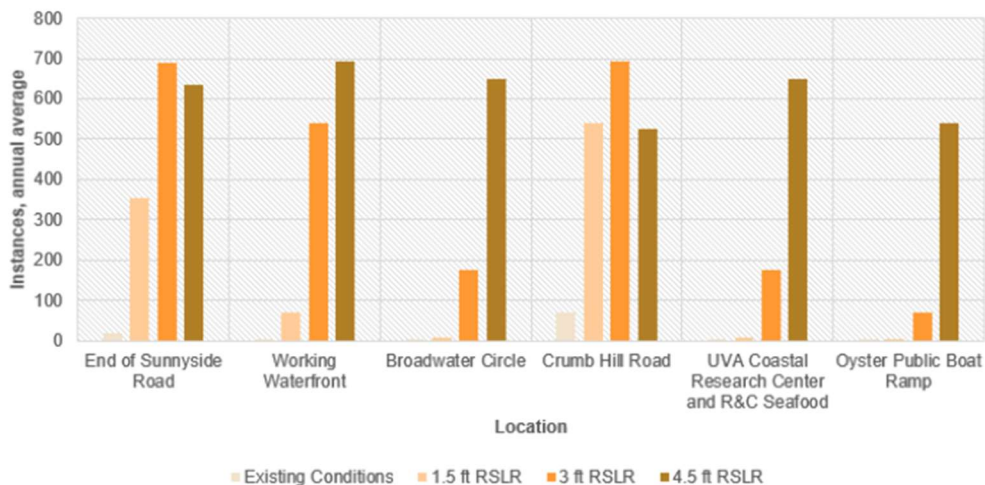
Figure 4: Chronic flood frequency instances at each location of interest (see figure 3) if the project is not implemented. Note the decrease observed for the End of Sunnyside Road and Crumb Hill Road between 3ft and 4.5ft SLR indicates that more area is projected to become permanently inundated.

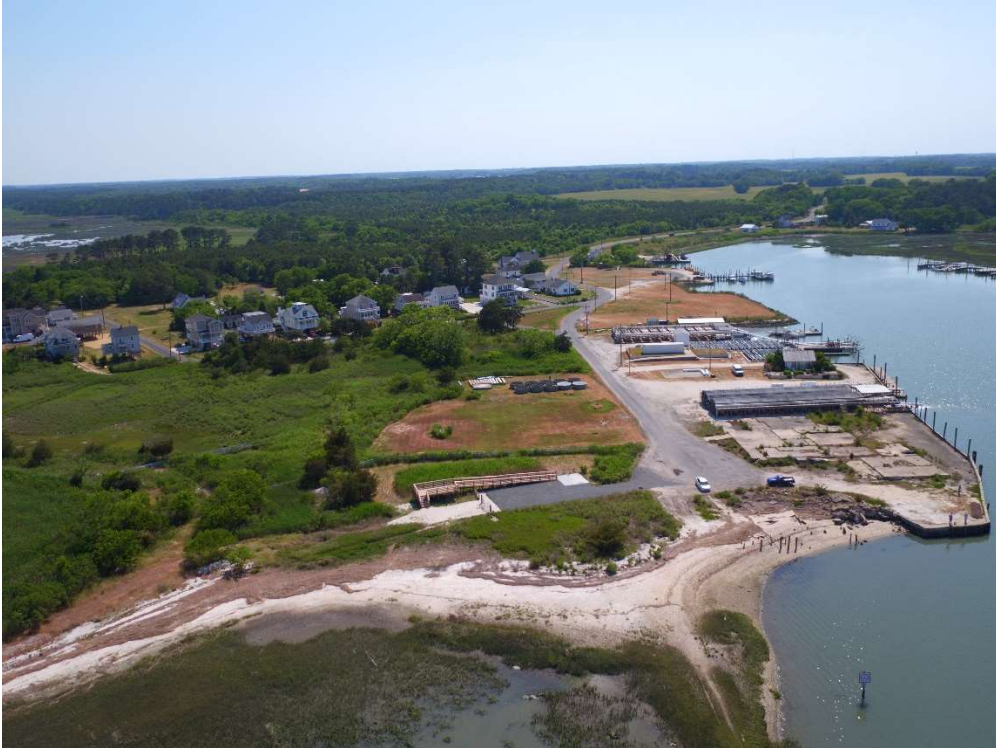
Photo 1: Drone photo of the south side of Oyster Harbor showing the working waterfront and homes on Broadwater Circle. The view is from the marsh looking landward. (Courtesy: Zak Poulto)

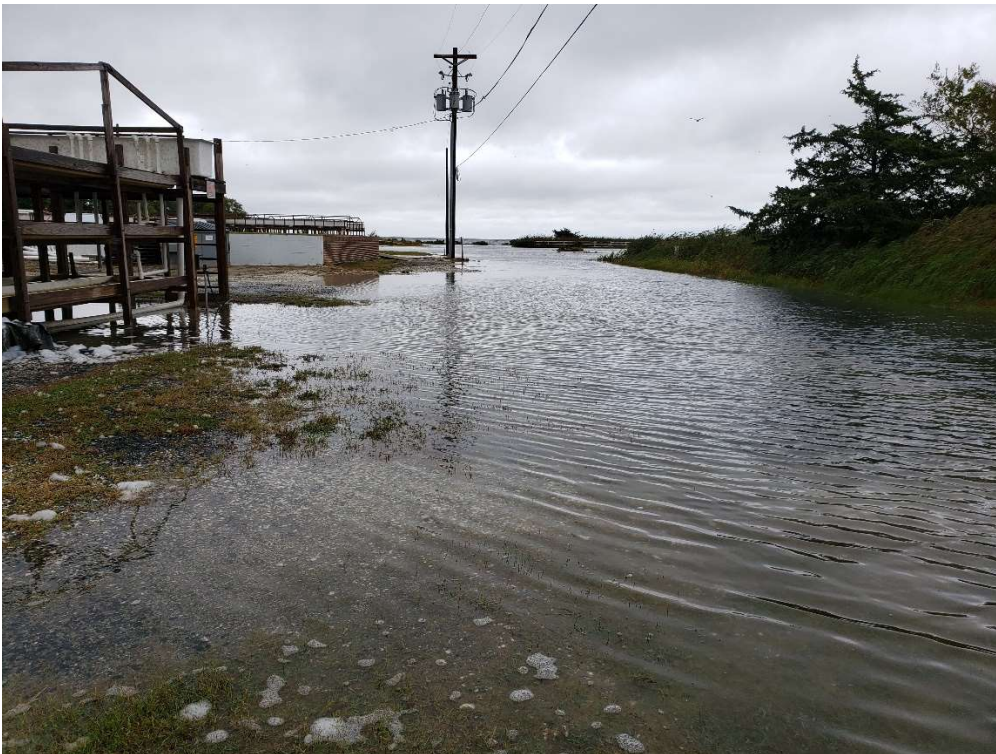
Photo 2: Flooding from a sunny day event. The photo is taken from Sunnyside Road next to TNC's Habitat Restoration Facility looking toward the marsh. An aquaculture facility is visible on the left side of the photo, and all of Sunnyside Road from here to the marsh is flooded. (Courtesy: Bo Lusk)

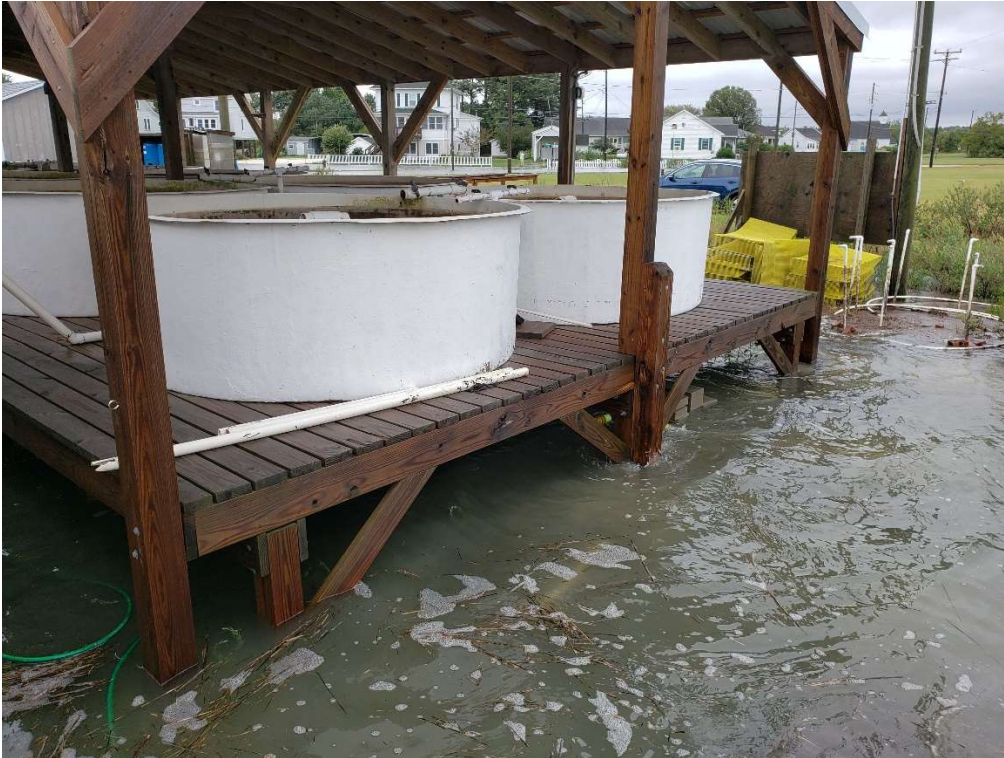
Photo 3: Flooding from sunny day event showing TNC's Habitat Restoration Facility. (Courtesy: Bo Lusk)

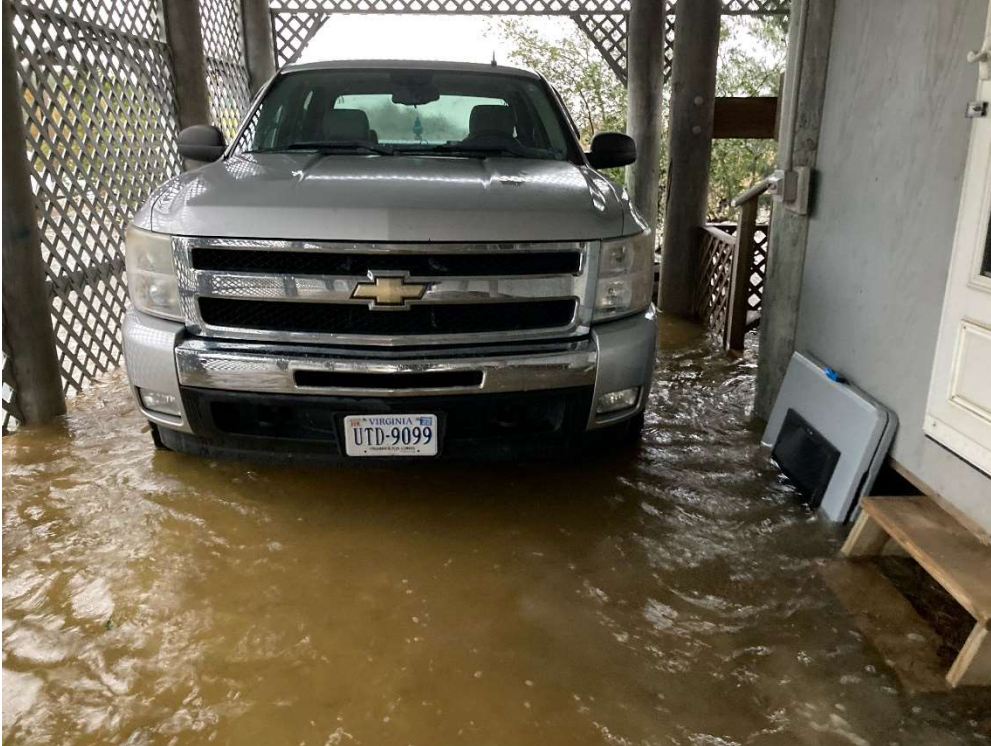
Photo 4: Flooding underneath a home on Broadwater Circle from an event in January 2022. (Courtesy: Donna Fauber)

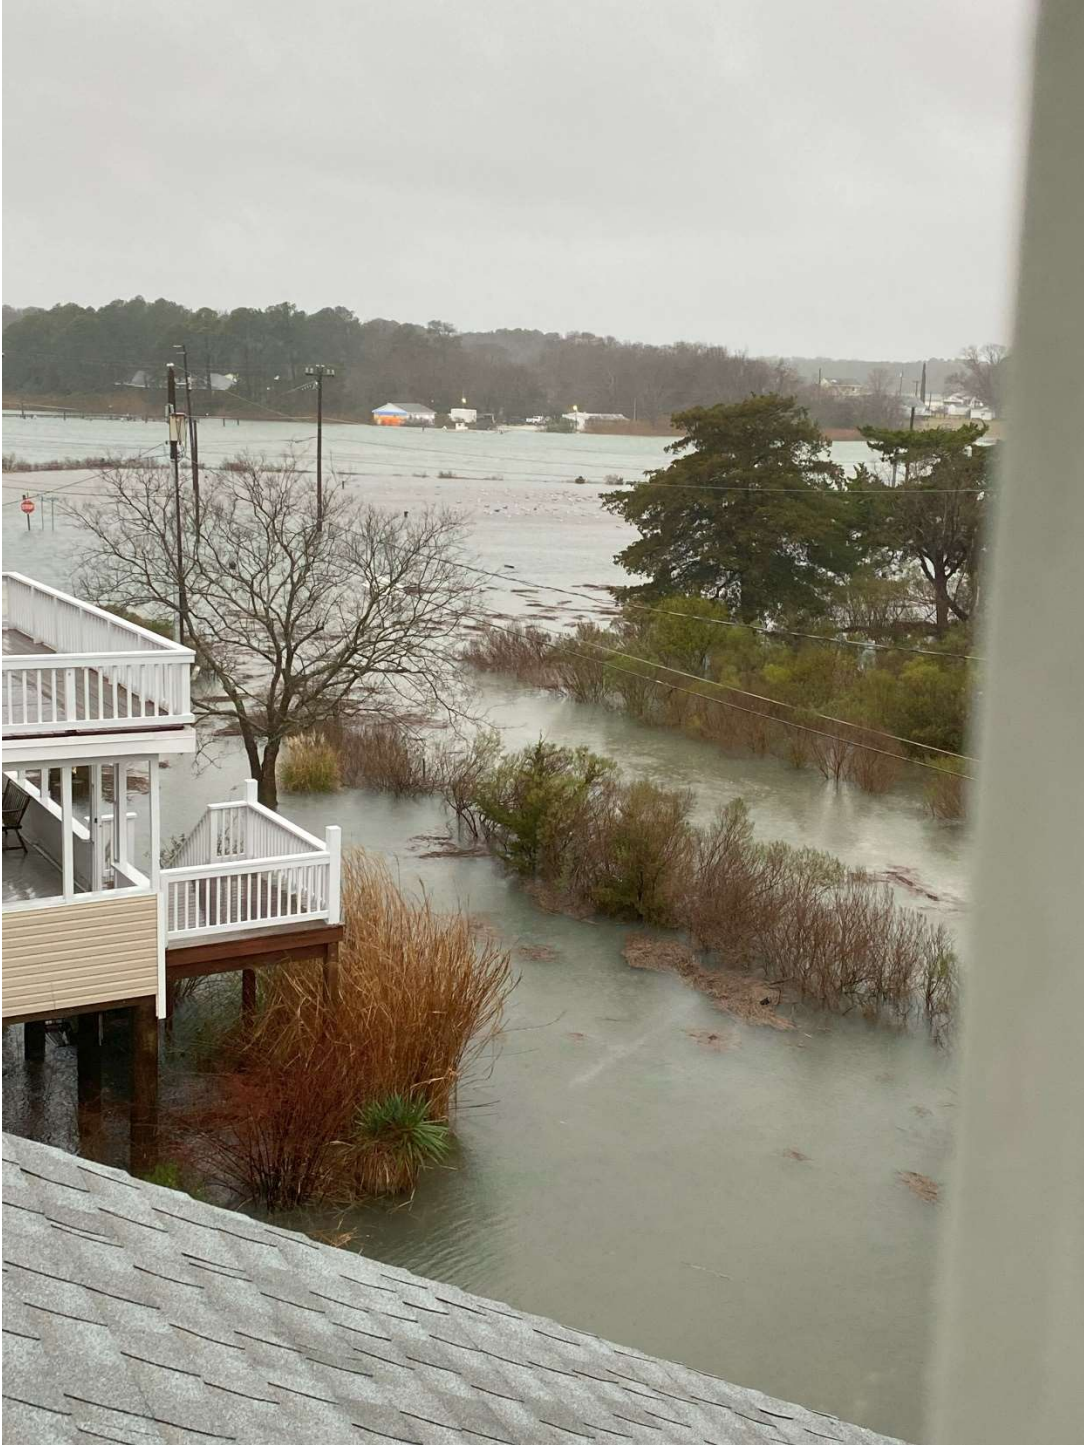
Photo 5: Photo taken from a home on Broadwater Circle of an event in January 2022. The view is northward showing buildings on the north side of the harbor. Everything in view between this house and the other side of the harbor is underwater, including Broadwater Circle (in front of the homes), Sunnyside Road (where the telephone poles and stop sign are). A line of vegetation is visible along the bulkhead. The stop sign in the photo indicates where Sunnyside Drive and Broadwater Circle meet. (Courtesy: Donna Fauber)

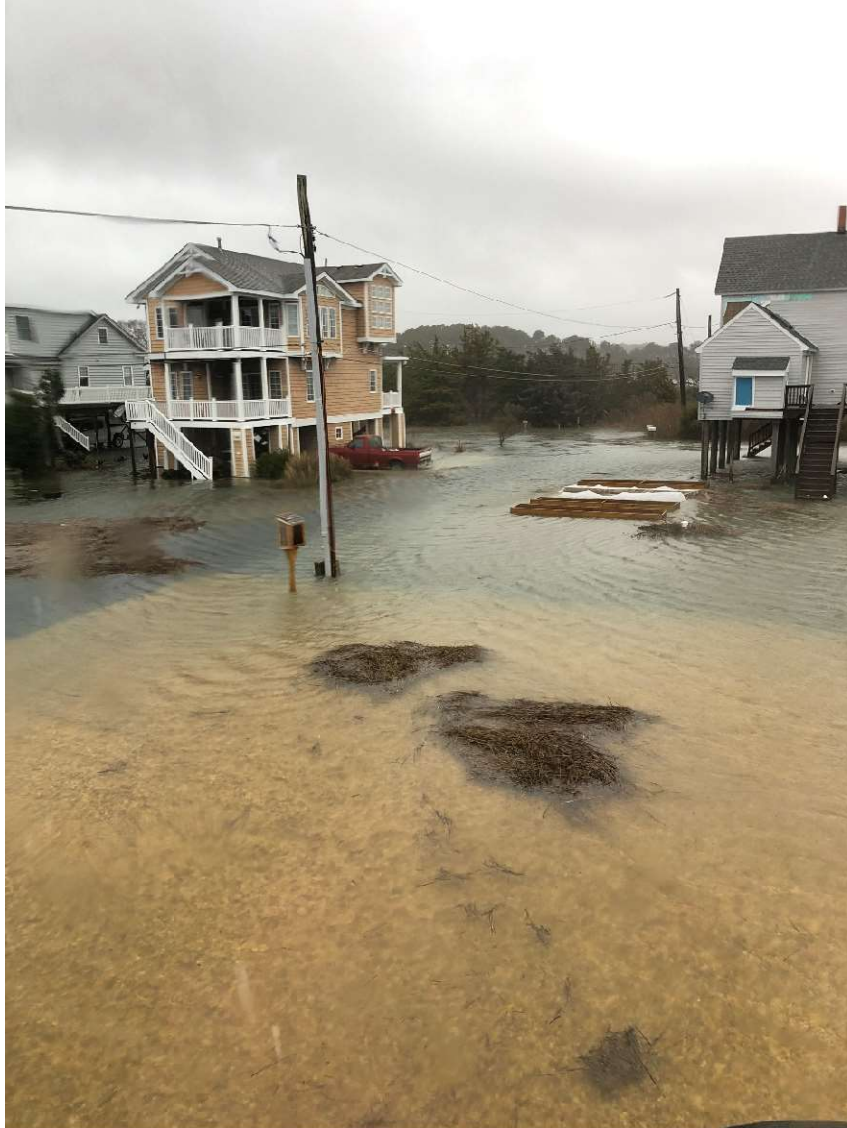
Photo 6: Flooding of the homes and road on Broadwater Circle during an event in January 2025.  
(Courtesy: Donna Fauber)
